APPENDIX A

Field Data sheets of individual erosion features with photographs.

FIELD DATA SHEET EROSION FEATURES ON TRAILS AND WATERCOURSES

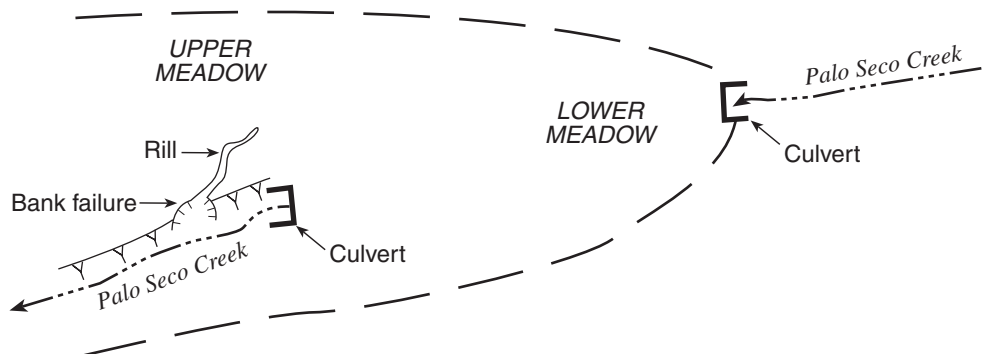
Feature Number: 01

Location of feature: In Upper Meadow, across from the bathrooms, on Palo Seco Creek. Feature is on the east side of the creek approximately 30 feet downstream from the culvert that drains Palo Seco Creek under the meadow.

Type of erosion feature and description: A rill that leads to a bank failure at the creek. The rill and bank failure are being created by surface runoff and possibly seepage from the meadow. This surface runoff could be caused by overflow at feature #22 during large rainfall events. Groundwater seepage from the meadow is another source of water that may contribute to this erosion.

Rill - 45ft X 0.6ft X 0.6ft = 16.2 ft³ = **0.6 yd³**

Bank failure - 4ft X 3ft X 2ft = 24 ft³ = **0.9 yd³**

Total = **1.5 yd³**

Potential for future erosion (low, moderate, high): Low

Priority for repair (low, moderate, high): Low

Potential mitigation: Future bank failure can be minimized by armoring the bank with large boulders. Additionally cleaning the culvert at feature #22 may prevent excessive runoff and prevent rill development.

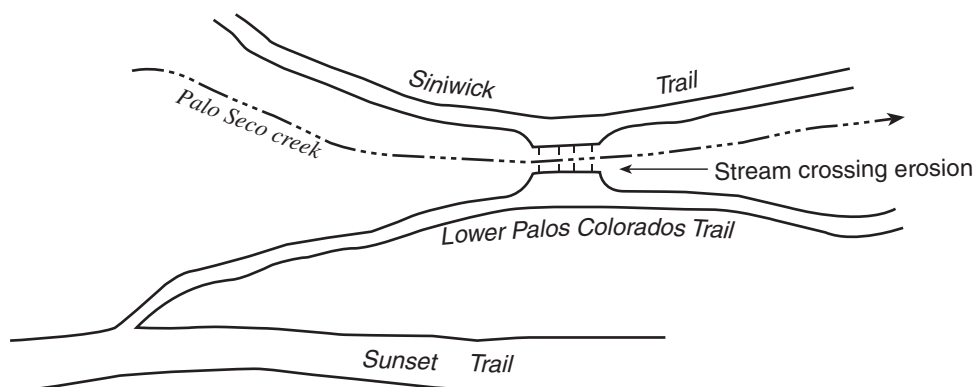
Feature Number: 02

Location of feature: On Palo Seco Creek at the crossover between Sinawik Trail and Lower Palos Colorados Trail.

Type of erosion feature and description: Fill emplaced across creek is being eroded away. It is possible that there was previously a culvert in place at the site that has been removed. Presently there are vertical banks of fill approximately 2.5 ft. high that are susceptible to bank erosion. Bank erosion will continue until the creek reestablishes its natural banks.

Fill erosion - 20ft X 4ft X 2.5ft = 200 ft³ = **7.4 yd³**

Potential for future erosion (low, moderate, high): High potential for erosion during high stream flow

Priority for repair (low, moderate, high): Moderate priority due to relatively small volume of sediment available for erosion

Potential mitigation: Bank erosion could be minimized by removing the leftover fill and sloping the banks back a few feet to restore gradual stream bank slopes. A small bridge could be constructed to maintain access between the two trails.

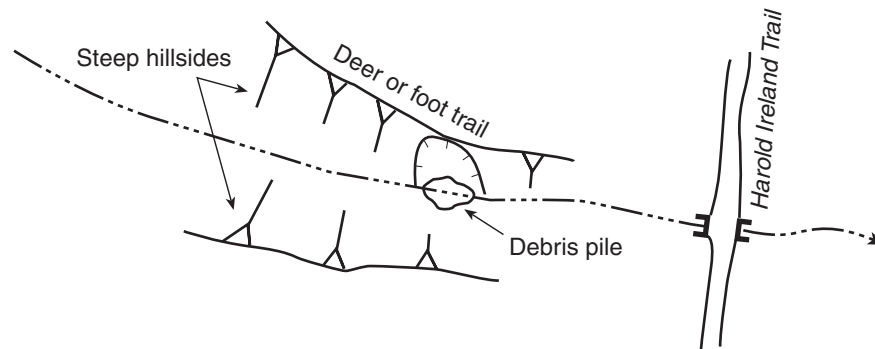
Feature Number: 06

Location of feature: East bank of Fern Trail creek upstream of Harold Ireland Trail crossing.

Type of erosion feature and description: Bank failure caused by high stream flows eroding the base of a steep slope. Bulk of the debris is in stream channel and will be transported downstream in winter flows. Debris is fresh and feature probably occurred in the winter of 1999 or 2000.

$$12\text{ft} \times 12\text{ft} \times 3\text{ft} = 720 \text{ ft}^3 = 16 \text{ yd}^3$$

Potential for future erosion (low, moderate, high): High for debris in stream channel,
Low for debris left on sideslope.

Priority for repair (low, moderate, high): Low

Potential mitigation: None

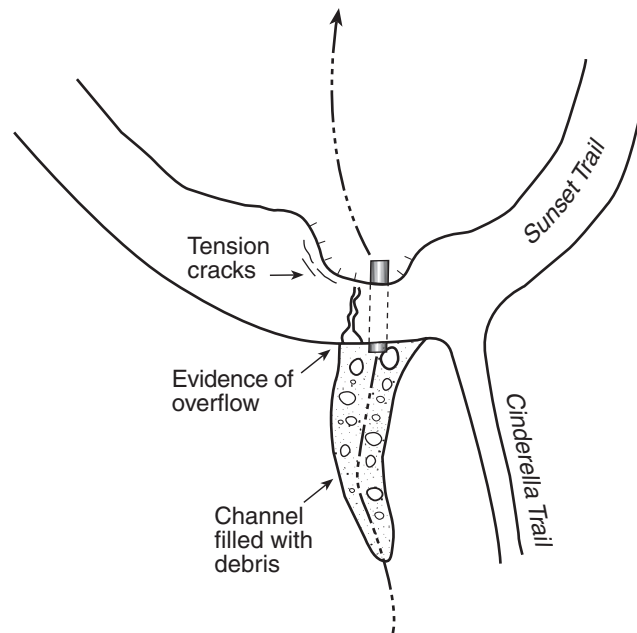
Feature Number: 07

Location of feature: Culvert at the junction of Cinderella Trail and Sunset Trail.

Type of erosion feature and description: Fill failure at stream crossing. There are concrete slabs on the margins of the fill that may be old bridge abutments or retaining structures. There is evidence (small rills) that the stream overtops the culvert in high flow. Culvert flow capacity is reduced by approximately 20% by a large rock and sticks blocking the inlet. Concrete culvert may be too small, (sediment has accumulated upstream).

$$15\text{ft} \times 20\text{ft} \times 8\text{ft} = 2,400 \text{ ft}^3 = 88.9 \text{ yd}^3$$

Potential for future erosion (low, moderate, high): High, potential future volume approximately $15\text{ft} \times 10\text{ft} \times 8\text{ft} = 1,200 \text{ ft}^3 = 44.4 \text{ yd}^3$

Priority for repair (low, moderate, high): High

Potential mitigation: A backhoe should be used to remove crossing fill. Fill could be replaced with a wooden bridge. If fill is not removed, then sediment upstream of culvert should be removed and culvert should be replaced with a larger one.

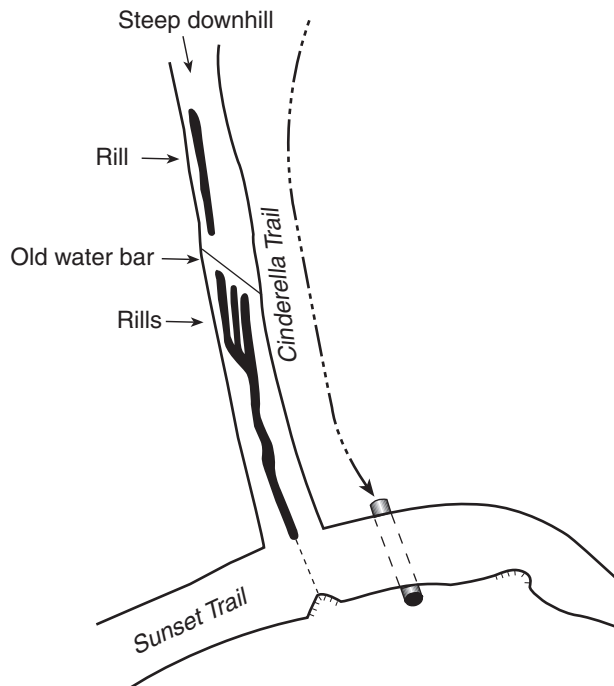
Feature Number: 08

Location of feature: Bottom 150 ft of Cinderella Trail from Sunset Trail junction.

Type of erosion feature and description: Rills have formed along the fall line of the trail by surface flow running down steep slopes and over dysfunctional water bars. Existing water bars are filled with gravels and soil and do not funnel water off the trail. Rills transport water across Sunset Trail and have contributed to a small fill failure on outer edge of road.

$$\begin{aligned} 62\text{ft} \times 1\text{ft} \times 0.3\text{ft} &= 18.6 \text{ ft}^3 = \mathbf{0.7 \text{ yd}^3} \\ 8\text{ft} \times 1\text{ft} \times 0.3\text{ft} &= 2.4 \text{ ft}^3 = \mathbf{0.1 \text{ yd}^3} \\ 8\text{ft} \times 1\text{ft} \times 0.3\text{ft} &= 2.4 \text{ ft}^3 = \mathbf{0.1 \text{ yd}^3} \\ 60\text{ft} \times 0.5\text{ft} \times 0.2\text{ft} &= 6 \text{ ft}^3 = \mathbf{0.2 \text{ yd}^3} \\ 30\text{ft} \times 1.5\text{ft} \times 0.3\text{ft} &= 13.5 \text{ ft}^3 = \mathbf{0.5 \text{ yd}^3} \\ \text{Total} &= \mathbf{1.6 \text{ yd}^3} \end{aligned}$$

Potential for future erosion (low, moderate, high): Moderate because future sediment volume will be low. Rills will enlarge with time.

Priority for repair (low, moderate, high): High

Potential mitigation: Clean out 4 water bars and cut them deeper. Water bars should be maintained yearly.

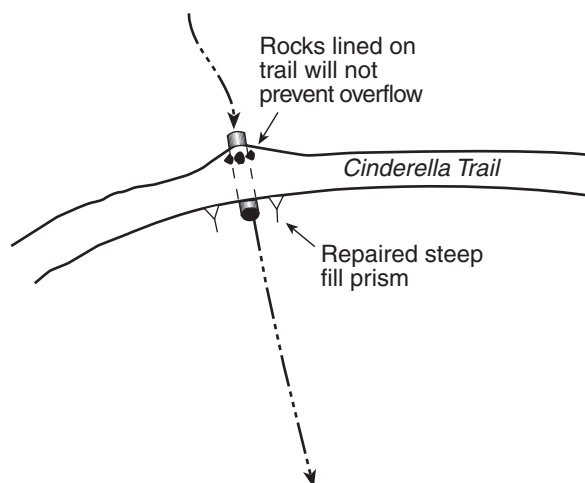
Feature Number: 09

Location of feature: Stream crossing on Cinderella Trail approximately 600 feet uphill from the junction of Cinderella Trail and Sunset Trail.

Type of erosion feature and description: This site is a stream crossing site that has seen storm flows overtop the trail in the past. Presently, the culvert is clear and functioning properly. The stream carries a coarse bed load and is approximately 6 feet wide bank to bank. Based on the size of the canyon, width of the stream, and coarseness of the bedload, the culvert may be too small to handle extreme flows.

Volume of past erosion (length X width X depth): Unknown, the culvert and crossing have been repaired in the past.

Potential for future erosion (low, moderate, high): Moderate, if the culvert is overtopped by stormflow the trail fill could wash out. Potential volume = $14\text{ft} \times 8\text{ft} \times 5\text{ft} = 560\text{ft}^3 = 20.7\text{yd}^3$

Priority for repair (low, moderate, high): Moderate priority for repair based on high cost due to limited equipment access.

Potential mitigation: Culvert should be inspected after large storms and cleaned and maintained as necessary. If problems persist, culvert can be replaced by a short wooden bridge.

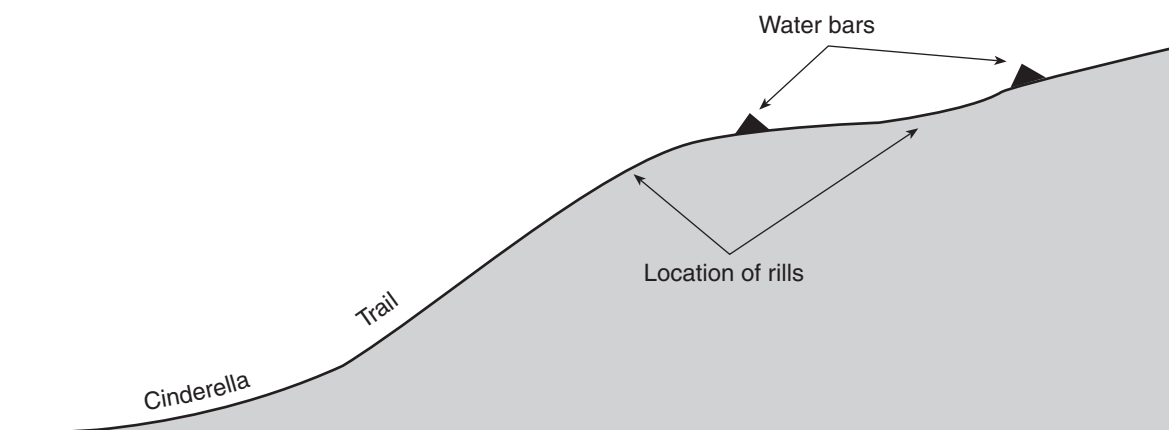
Feature Number: 10

Location of feature: Approximately 500 feet uphill from site # 09 there is a section of trail that is very steep.

Type of erosion feature and description: Rills and small gullies forming in trail. There is a 200 foot long section of trail that has no way for water to drain off of it. Therefore, water runs down the trail causing small rills. The largest rill in this section occurs where the trail gradient changes from moderate to steep. Recreational trail use contributes to the raveling of loose material existing in rills created by surface runoff.

$$40\text{ft} \times 1.5\text{ft} \times 0.5\text{ft} = 30 \text{ ft}^3 = 1.1 \text{ yd}^3$$

Potential for future erosion (low, moderate, high): High. Rilling will continue if no action is taken to divert water flowing down trail. Rilling will not erode very deep because of shallow bedrock conditions.

Priority for repair (low, moderate, high): High

Potential mitigation: The streamside edge of the trail should be cut in at least 2-3 places upslope of the rills to allow water to flow off the trail. Water bars should be installed to direct the water to the new flow exit channels. One water bar should be installed at the top of the steepest section.

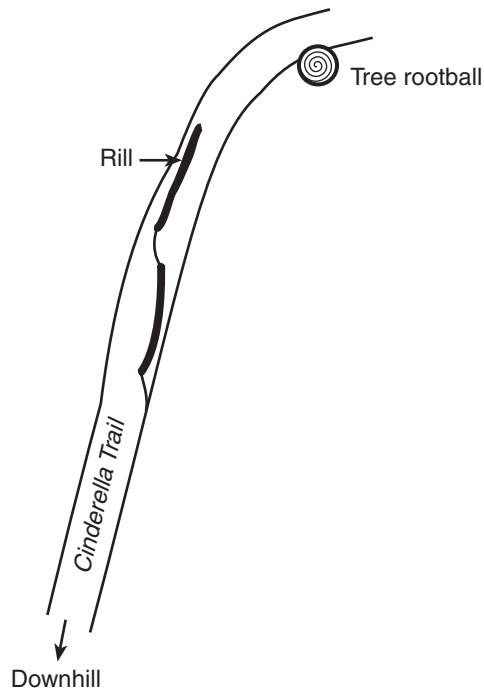
Feature Number: 11

Location of feature: Cinderella Trail, approximately 400 feet uphill from site # 10, downhill from an old tree root ball on the edge of the trail.

Type of erosion feature and description: Small rill caused by water flowing down steep section of trail. The water has no possible way to exit the trail.

$$50\text{ft} \times 0.5\text{ft} \times 0.2\text{ft} = 5 \text{ ft}^3 = 0.2 \text{ yd}^3$$

Potential for future erosion (low, moderate, high): Moderate, but with low volume.

Priority for repair (low, moderate, high): Low

Potential mitigation: Two waterbars should be installed above the root ball. The berm on the outside edge of the trail should be cut to allow passage of water. Trail below the root ball could also be regraded.

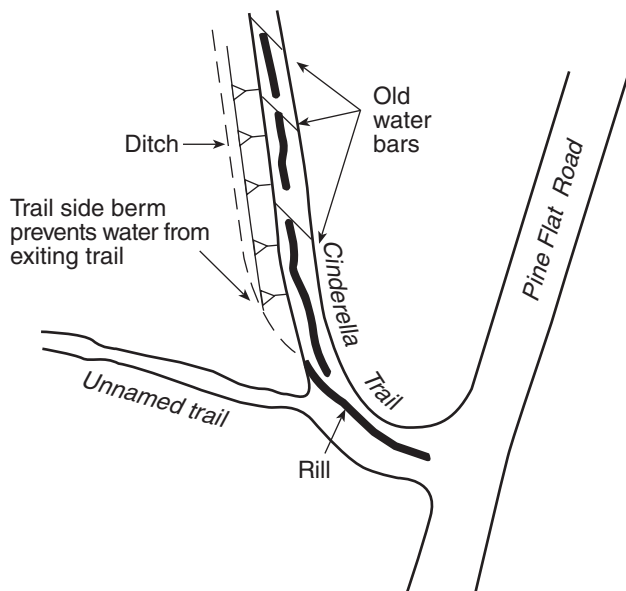
Feature Number: 12

Location of feature: Cinderella Trail at the junction with Pine View Flat Road

Type of erosion feature and description: Rilling on the trail. Small rills persist from Pine View Flat Road downhill on Cinderella Trail for 140 feet. The rills are caused by improper drainage of storm water on a steep trail. Waterbars and cross-trail ditches constructed in the past have filled with sediment and are no longer efficient at removing water from the trail.

$$\text{Total} = \mathbf{1.28 \text{ yd}^3}$$

Potential for future erosion (low, moderate, high): High

Priority for repair (low, moderate, high): High

Potential mitigation: Repair existing waterbars and maintain channels through the high berm on the streamside of the trail. Also clean out existing cross-trail ditches and outboard ditch.

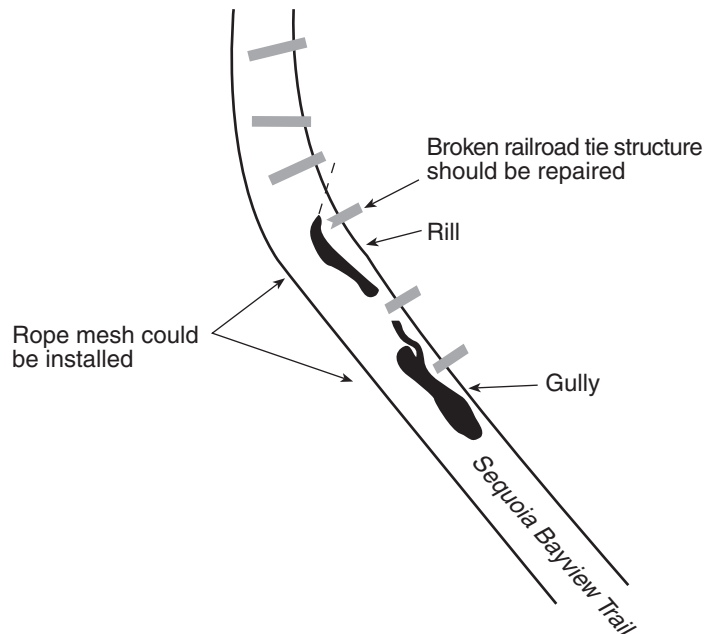
Type of erosion feature and description: Rills and Gullies. Old wooden erosion control beams were placed in the trail, but have not been maintained. One large rill occurs where there is a gap in these structures. A gully occurs where one of the structures is broken. Surface water runoff is the main source of erosion presently contributing to rill development. Storm water flows through channels created through years of land use. Based on the proximity of the site to the horse arena, we suspect that the channels were originally created by recreational horse traffic.

Priority for repair (low, moderate, high): Moderate, based on low volume of expected future erosion.

Potential mitigation: There is no good location to divert the water that is causing the erosion. Sediment retention structures, such as rope mesh could help keep some of the soil in place. Broken beam should be replaced. The trail could be regraded and locally covered in a layer of gravel.

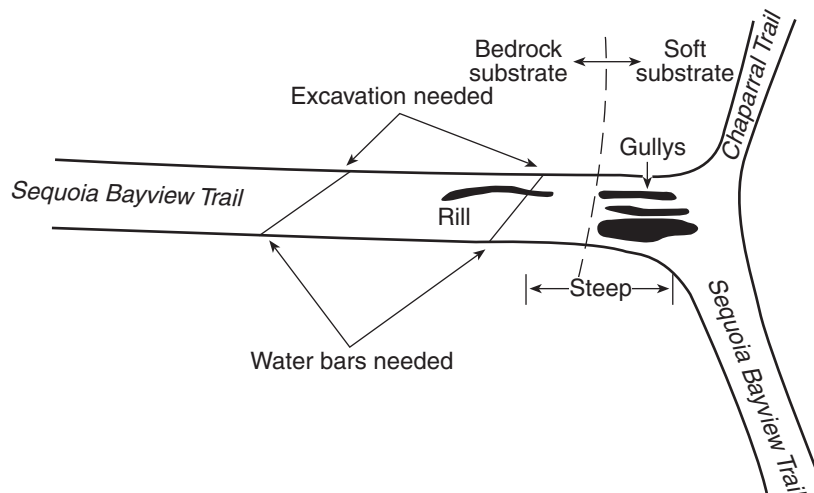
Feature Number: 15

Priority for repair (low, moderate, high): High

Potential mitigation: Install a water bar at the top of the steep section and one about 40 feet up trail from the steep section. At each waterbar, the high outside berm has to be excavated to provide a path for water to exit the trail. The steep lower section should be regraded. Water bars will keep water away from steep section and minimize future gully development. Alternatively, stairs or armor structures could be installed at the site.

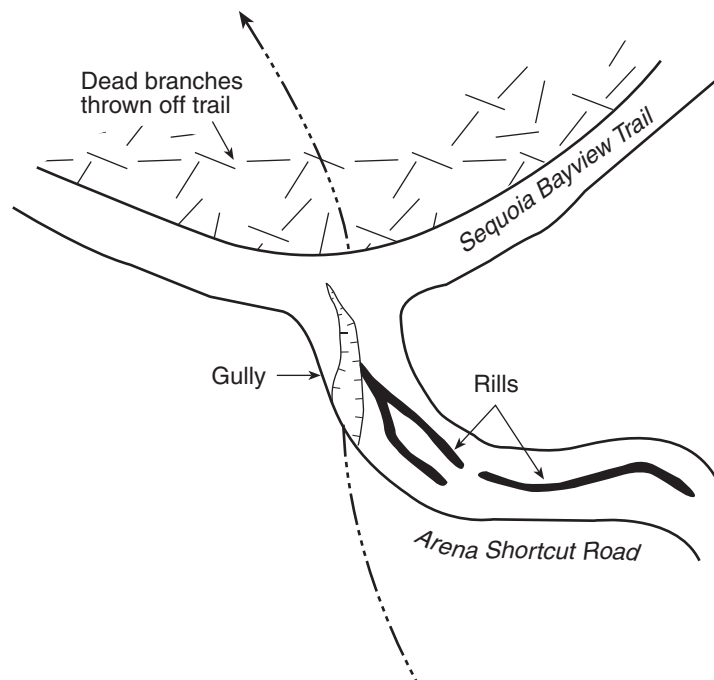
Feature Number: 16

Priority for repair (low, moderate, high): High

Potential mitigation: The drainage of the entire junction could be redone. Drainage from the stream channel could be diverted through a culvert across the fill to maintain the road configuration. Alternatively, the stream could be left alone. This would allow the stream to eventually recapture its old channel. A bridge could be constructed when the gully becomes too deep.

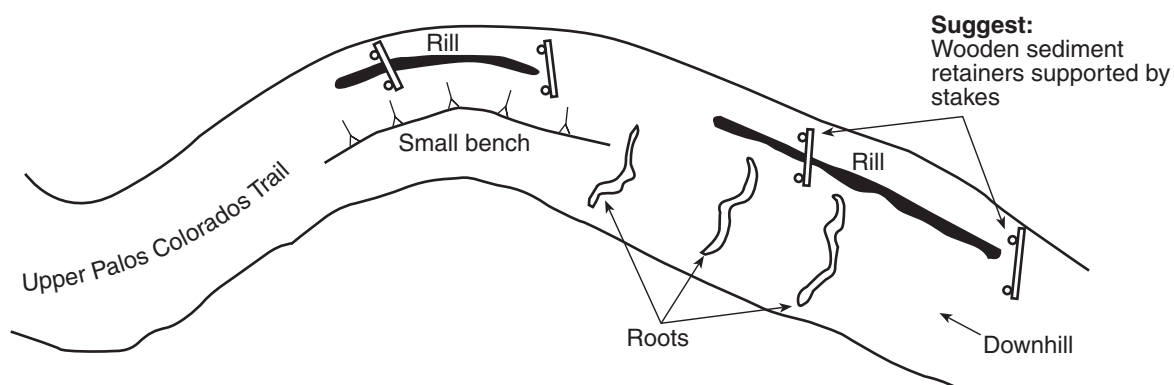
Feature Number: 21

Type of erosion feature and description: Rills around roots. At the top of the trail water cannot exit trail. This flow of water down the trail is the initial cause of the rilling. Landuse over the top of the rills has helped them to expand.

Priority for repair (low, moderate, high): High

Potential mitigation: Install sediment retaining structures such as wooden boards supported by rebar stakes. These will help keep loosened soil on the trail. The sediment retainers should be angled off the trail to be used as water diverters at the same time. Wooden retention structures can function as steps for hikers in addition to holding soil on the trail. Regrading is not possible because redwood roots could be damaged.

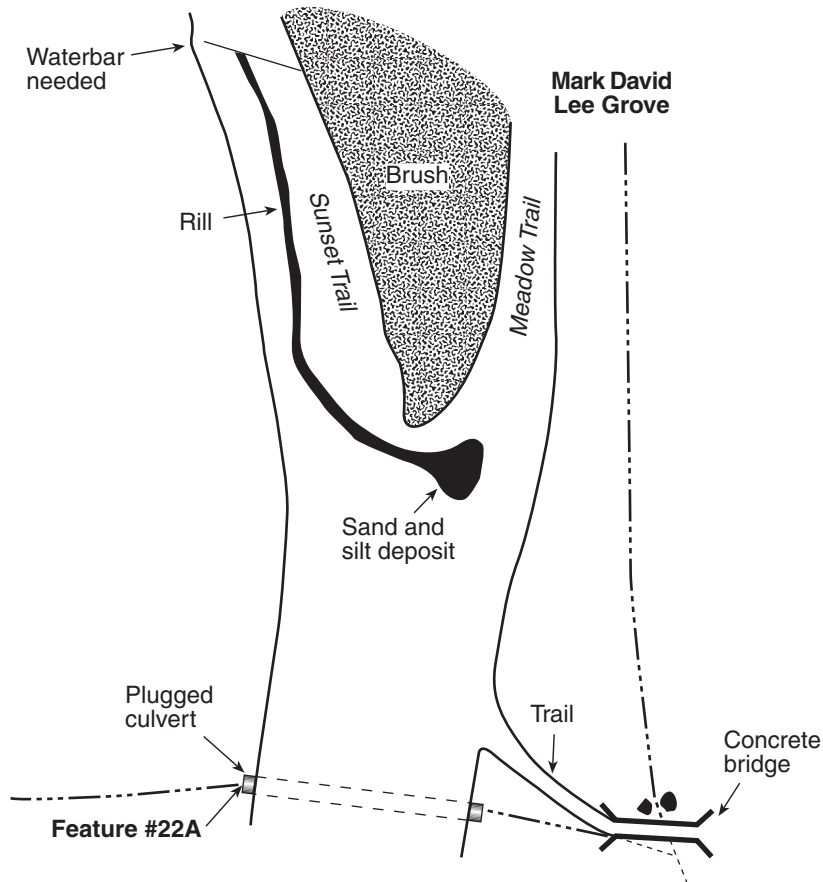
Feature Number: 22 and 22A

Priority for repair (low, moderate, high): Low, small volume expected in the future

Potential mitigation: Install water bar at top of small hill at the beginning of the rill to divert runoff into the brush. Existing inboard ditch will not function properly without installing a ditch relief culvert. The culvert near the concrete bridge should be cleaned out.

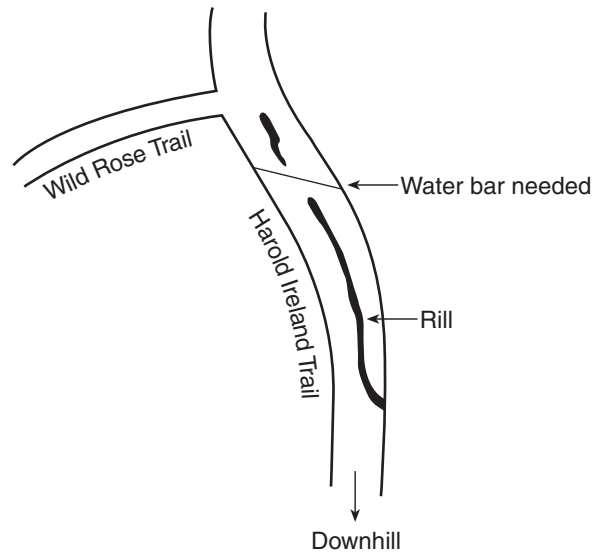
Feature Number: 23

Type of erosion feature and description: Rill caused by improper drainage.

Priority for repair (low, moderate, high): Low

Potential mitigation: Install small water bar near top of feature to prevent future rill development.

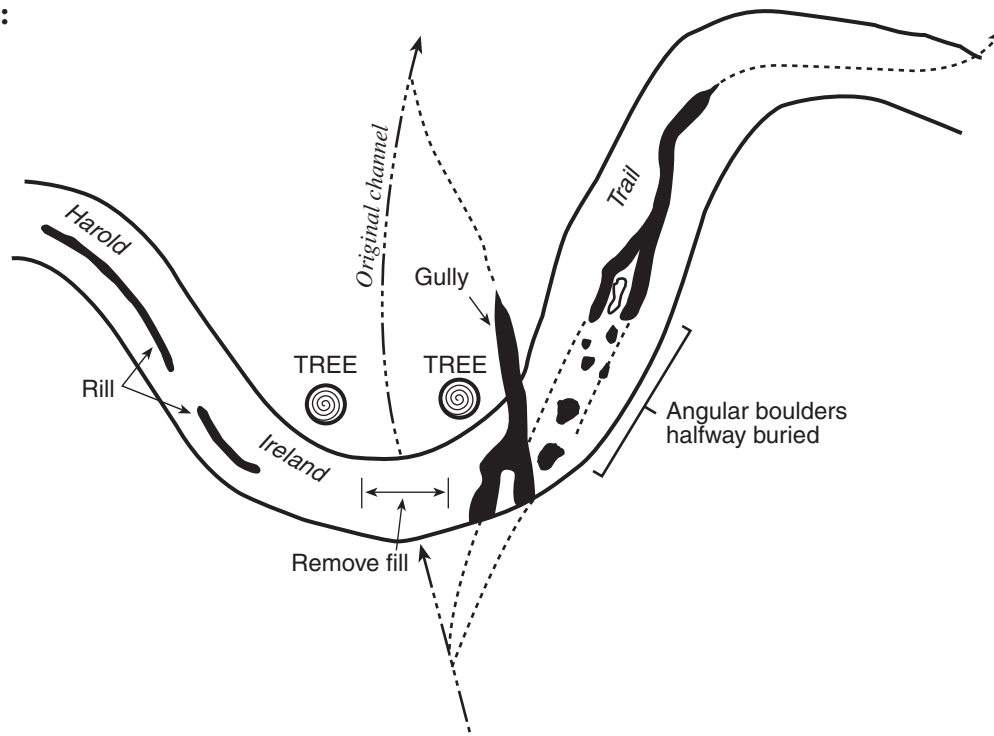
Feature Number: 24

Type of erosion feature and description: Rill and gully. These features are caused by water flowing over trail fill. The trail fill blocks the natural channel and forces water down the trail. Water flows out of the stream channel and onto the trail.

Priority for repair (low, moderate, high): High

Potential mitigation: Remove fill in stream channel to restore original channel. Place fill in existing gully to prevent runoff from following the trail. Excavate between the two big trees (see sketch) to help the stream reoccupy its original channel. Trail should gently slope into and out of the stream channel. Also install a small water bar at top of rill on south side of stream

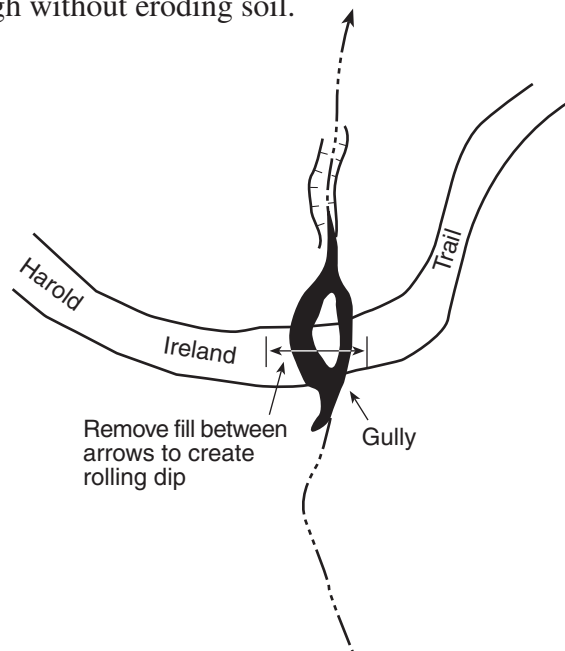
Feature Number: 25

Priority for repair (low, moderate, high): High

Potential mitigation: Remove trail fill existing in channel to create a rolling dip. Trail should gently slope into and out of stream channel. Winter flows can then pass through without eroding soil.

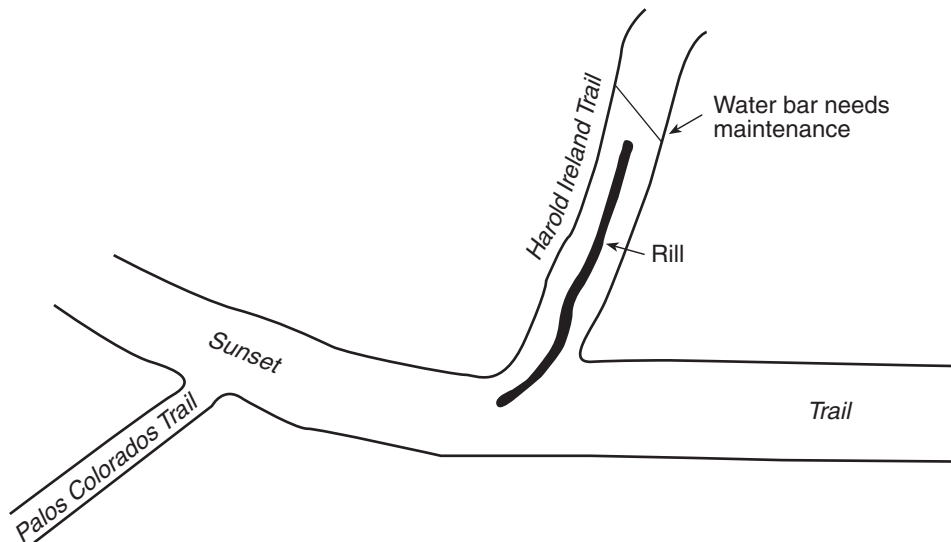
Feature Number: 26

Type of erosion feature and description: Rill caused by water flowing down the compacted trail. There is a disfunctional water bar at the beginning of the rill.

Priority for repair (low, moderate, high): Low

Potential mitigation: Deepen existing water bar so that it diverts water off the trail into the brush.

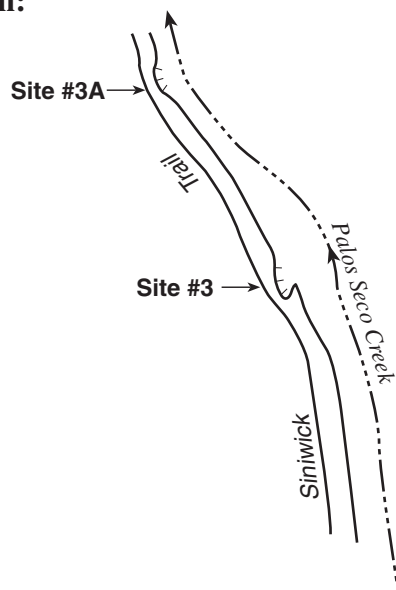
Feature Number: 03 and 03A

Type of erosion feature and description: Both feature #03 and #03A are bank failures caused by high flows on Palo Seco Creek, possibly enhanced by ground water seepage into the creek from beneath the trail.

Priority for repair (low, moderate, high): Moderate, repair will assure that the trail is not eroded any further

Potential mitigation: Bank retention structures could be built to minimize bank erosion and maintain trail width. Possible retention structures include rebar stakes and lumber (see below), boulders placed in eroded void, or timber crib walls.

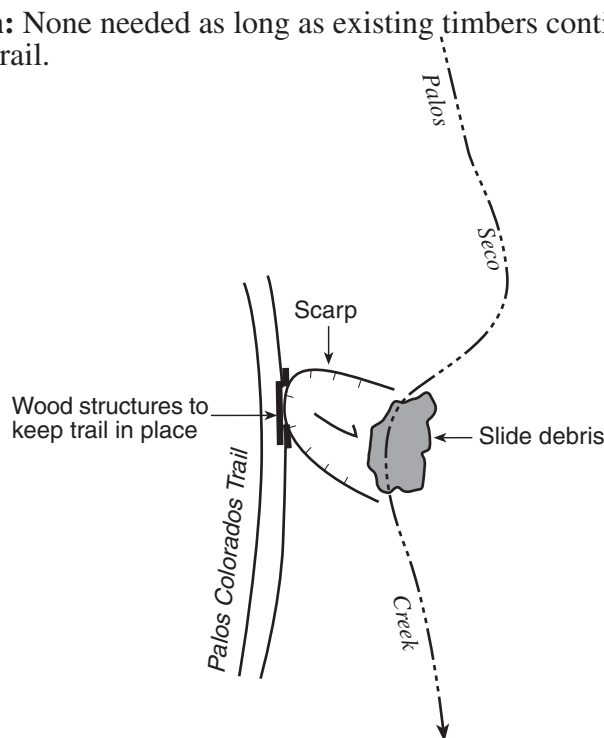
Feature Number: 04

Type of erosion feature and description: Stream bank landslide. Lower Palos Colorados Trail trends across the head scarp of the slide and has been stabilized with timbers. Slide was most likely caused by natural stream erosion at the base of a steep slope. The slide does not appear to have been affected by Palos Colorados Trail. Approximately 25% of the slide material is piled up in the stream channel. The majority of the slide material has been transported downstream.

Priority for repair (low, moderate, high): Low

Potential mitigation: None needed as long as existing timbers continue to effectively stabilize the trail.

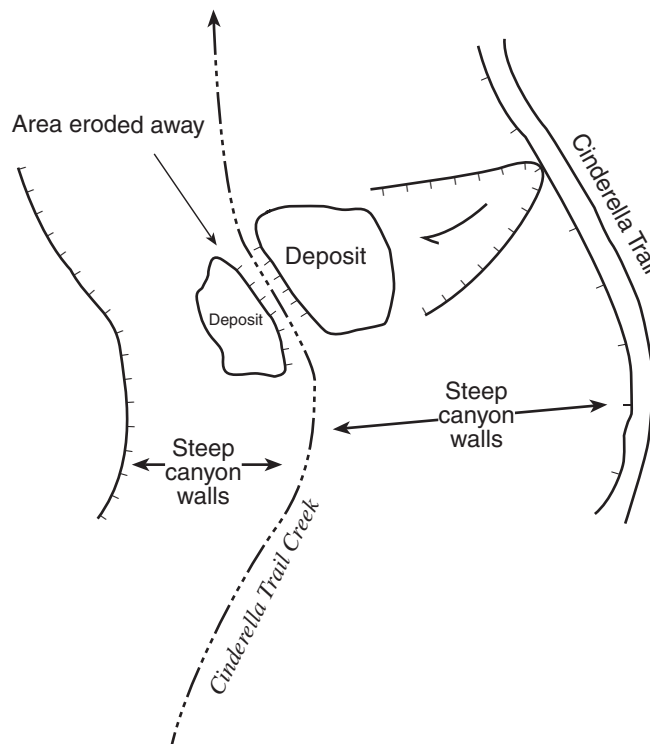
Priority for repair (low, moderate, high): Low

Potential mitigation: None recommended. There is no trail access to the feature and any repair attempt would cause unnecessary damage to the stream.

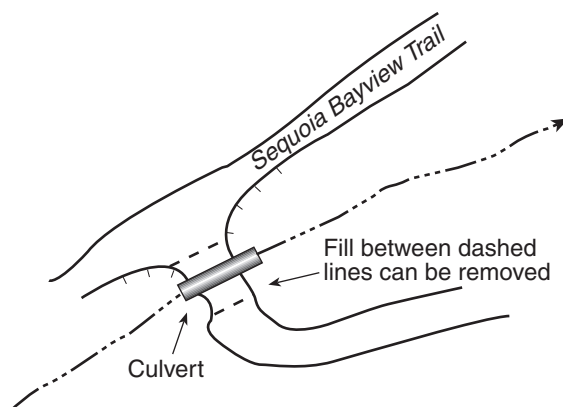
Feature Number: 17

Type of erosion feature and description: Culvert has been eroded by stream flow at both the upstream and downstream ends. Additionally, the top of the culvert is exposed at the surface of the trail and the bottom is rusted throughout.. Approximately 15% of the culvert inlet is plugged with debris. The culvert can easily be overtopped during high flow.

Priority for repair (low, moderate, high): low

Potential mitigation: The culvert could be pulled out. Fill material could be sloped back to original grade to prevent the transport of fill material downstream. A small wooden bridge could be constructed over the channel. Alternatively, the culvert could be replaced with a larger culvert that was set in more deeply.

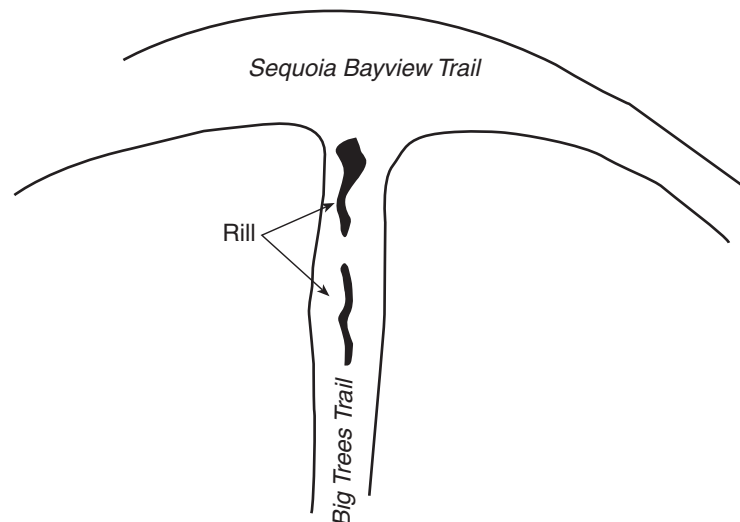
Feature Number: 18

Type of erosion feature and description: Rill in the middle of the trail. It ends at Sequoia Bayview Trail. About 30 ft. upslope from this feature there is another small rill. Both features are hard to see in the field. Bike tracks observed on both sides of the rill but not inside it. Based on the sinuous shape of the rill, we suspect surface runoff flowing down the trail is the primary cause of the rill.

Priority for repair (low, moderate, high): Low

Potential mitigation: None. Future rill development is limited by shallow bedrock conditions.

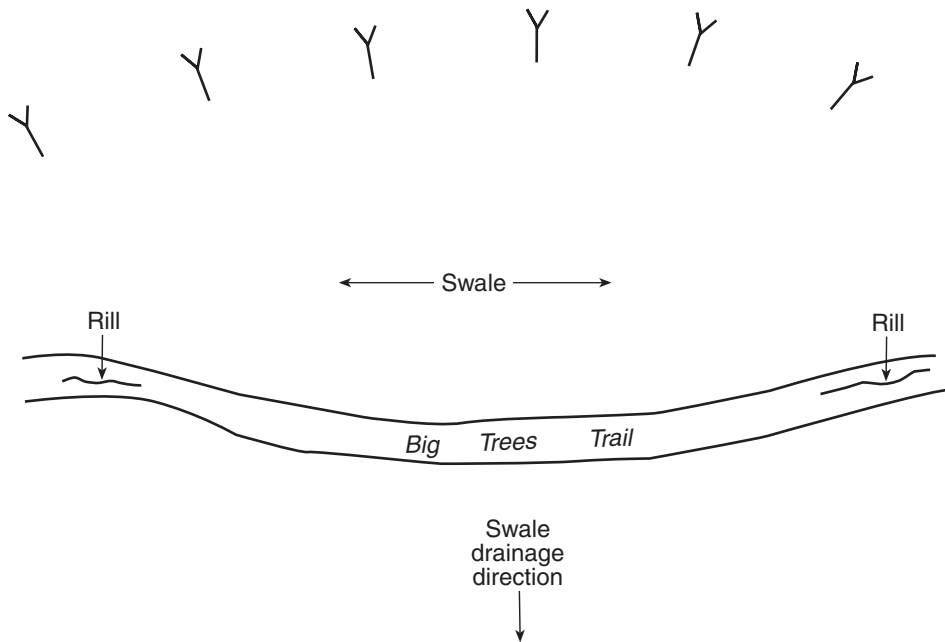
Feature Number: 19

Type of erosion feature and description: Small rills (one on north side of swale and one on south side of swale). The site is at the top of the drainage basin. Surface water flow over the compacted trail appears to be the primary cause of rill development.

Priority for repair (low, moderate, high): Low

Potential mitigation: No immediate action is needed. Site could be regraded to remove rills.

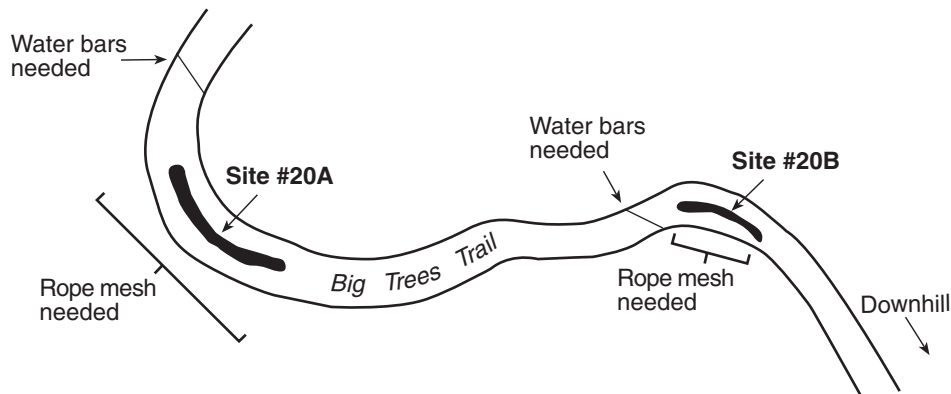
Feature Number: 20A and 20B

Priority for repair (low, moderate, high): High

Potential mitigation: Install rope mesh in and around the existing rills. This will serve as a sediment retainer and prevent the rills from growing larger. Also a water bar at the top of each feature would prevent water from feeding the rill. Alternatively, rills can be filled with gravel.

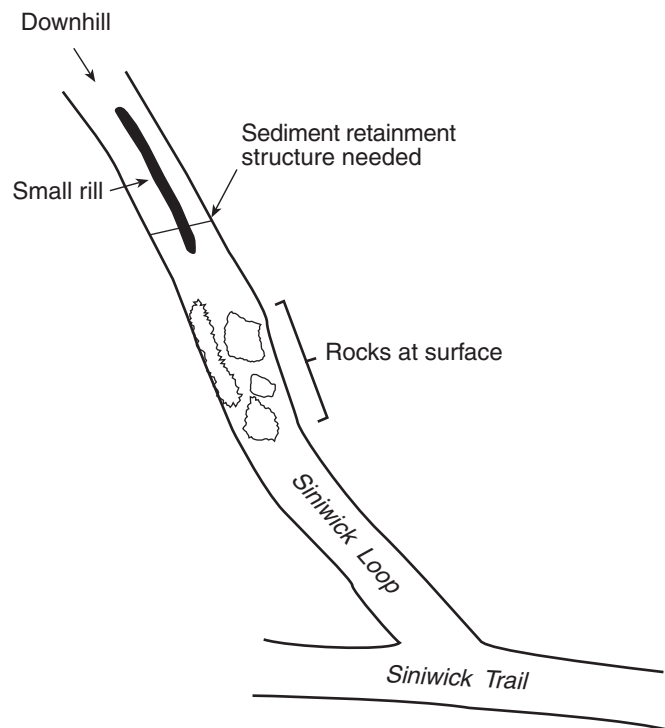
Feature Number: 27

Type of erosion feature and description: Rill, upslope from exposed rocks. The rill is caused by water running down the steep trail. Bicycles may brake before the rocks which may contribute to rill development.

Priority for repair (low, moderate, high): Low. Small volume of expected future erosion.

Potential mitigation: A sediment retention structure would prevent future rill development by trapping sediment.
