APPENDIX A

Field Data sheets of individual erosion features with photographs.

FIELD DATA SHEET EROSION FEATURES ON TRAILS AND WATERCOURSES

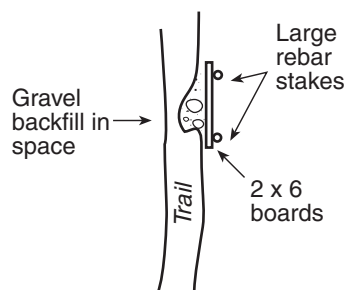
Example:
Retainment structure

Type of erosion feature and description: Both feature #03 and #03A are bank failures caused by high flows on Palo Seco Creek, possibly enhanced by ground water seepage into the creek from beneath the trail.
